18 August 1965

Suntracker Balloon Flights

Flights 3026, 3028, 3029, and 3031

Report No.: 2919
Project No.: 59541

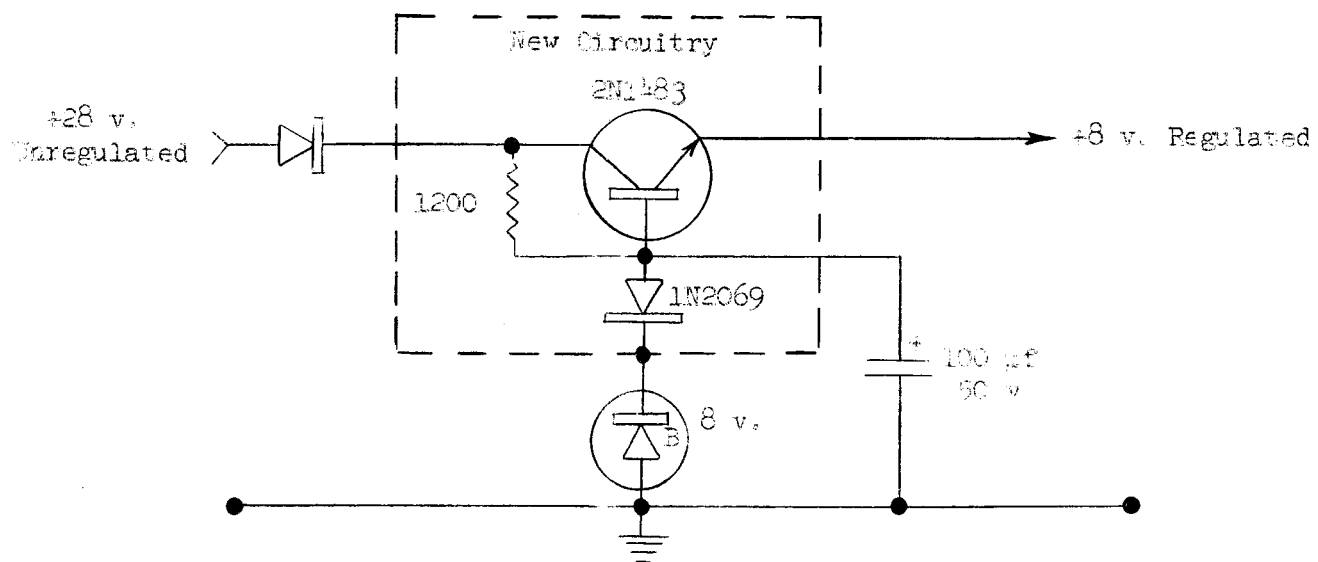
Figure 3. Schematic of Eight Volt Regulator Redesign

Several instrumentation problems encountered on the previous flight were analyzed and the circuitry repaired or reworked during the three-day period between Flight #3028 and Flight #3029. The temperature recorder attached to the telemetry transmitter on Flight #3028 revealed that 4-1/2 hours after launch the temperature reached a high of over 170°F. The temperature remained above this high level for 2-1/2 hours until the air flow and the cooler atmosphere encountered during descent dropped the temperature more than 100°F. (See time vs. temperature curves on page A-8 of appendix.) The subcarrier frequency shift encountered on Flight #3028 occurred during the time the instrument panel temperature was at its peak value. The solid-state transmitter, 8-volt regulator diode, and dropping resistors were capable of withstanding this extreme temperature rise; the 20-volt self-contained regulator mounted nearby has a maximum temperature rating of 150°F. Tests revealed that the 20-volt regulator did lose regulation at the extreme temperatures, allowing the voltage supply to the subcarrier oscillator to rise from 27.6 to 35 volts. The test verified that this voltage increase results in a frequency decrease of the magnitude recorded during the flight.

Several steps were taken to prevent a temperature buildup in this area of the instrumentation during future flights. The dropping resistors in the 8-volt regulator section were a major heat contributor. The regulator design was changed from a brute-force shunt configuration to a series regulator using a silicon power transistor as the series

control element. A circuit diagram of the revised configuration is shown in Figure 3. This design eliminates two large dropping resistors and requires only an additional transistor, biasing resistor, and temperature compensating diode. The same reference diode is used, but its shunt current is reduced by a factor of 32 times. Current drain from the battery is reduced by 520 milliamps, voltage regulation is slightly better, and temperature response is improved. The series transistor has low power dissipation and is mounted on a large heat dissipator attached to a cool area of the instrument panel away from the transmitter. The 20-volt regulator that overheated on the previous flight was checked and judged to have suffered no permanent damage; its mounting position was also moved away from the transmitter mounting position. A heat dissipating fin had been installed on the outside surface of the instrument panel before the last flight; this panel was painted flat white on its upper surface and black on its shaded areas. The top of the instrument container was also sprayed flat white and, in addition, just before launch a sheet of white cardboard was attached as a sun-shield just above the instrument box.

- The redesigned voltage regulator improved reliability considerably by completely eliminating a high temperature problem caused by high power dissipation.

- The new circuit, a series transistor configuration, reduced power dissipation from 17.1 watts to .5 watt. Current drain from the battery was thus reduced by more than .5 ampere.
